Rimkus Consulting Group, Inc.
Eight Greenway Plaza, Suite 500
Houston, TX 77046
(800) 580-3228 Telephone
(713) 623-4357 Facsimile

Re: RCG File No: 11009971
LLV Number: 0209452
VMF Location: 1530 Greensmark Drive in Houston, Texas
Subject: Final Report

Rimkus Consulting Group, Inc. was retained to examine LLV 0209452, VIN 1GBCS10E4M2908832. The fire occurred on June 13, 2016 at around 12:30 P.M. the operator of the vehicle at the time of the fire, was unavailable for interview but reportedly stated the vehicle's engine died while delivering mail on his route and backfired during subsequent attempts to restart it. Soon thereafter, smoke was observed from beneath the hood as well as flames.

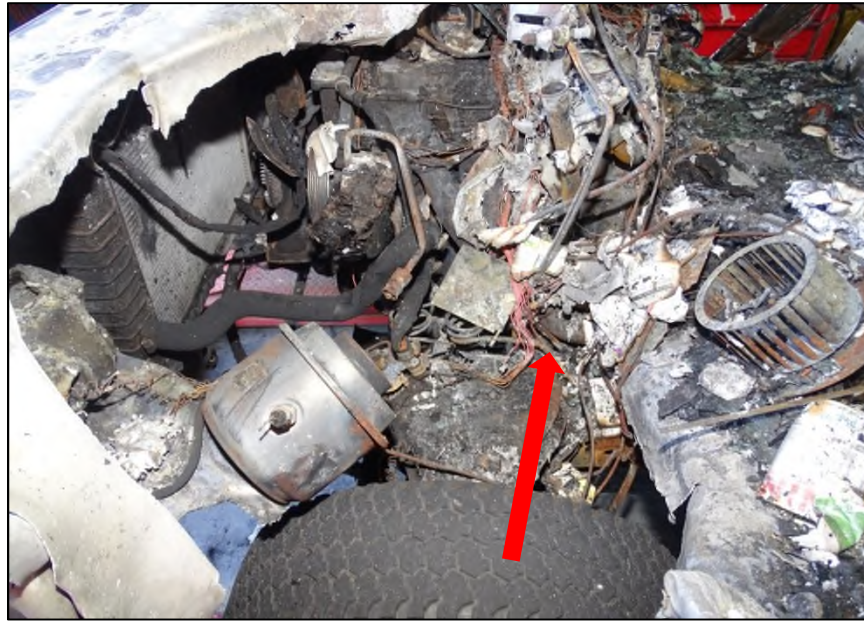
Photograph 7

Closer view of the area of origin. Note the most severe damage is at the position where the bulkhead/dashboard had been positioned.

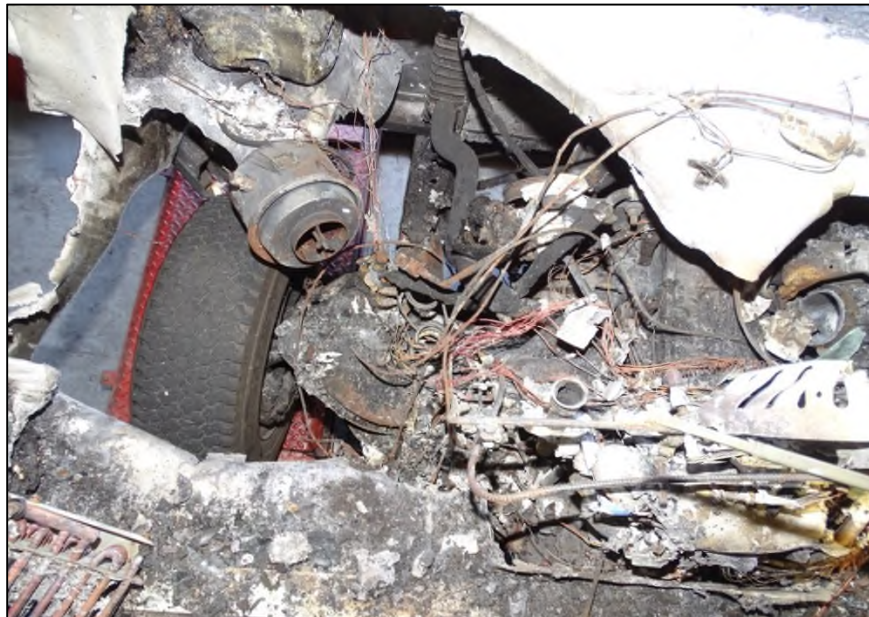
Photograph 8

Another view of the area of origin from the operator's compartment showing the conductors in the area.

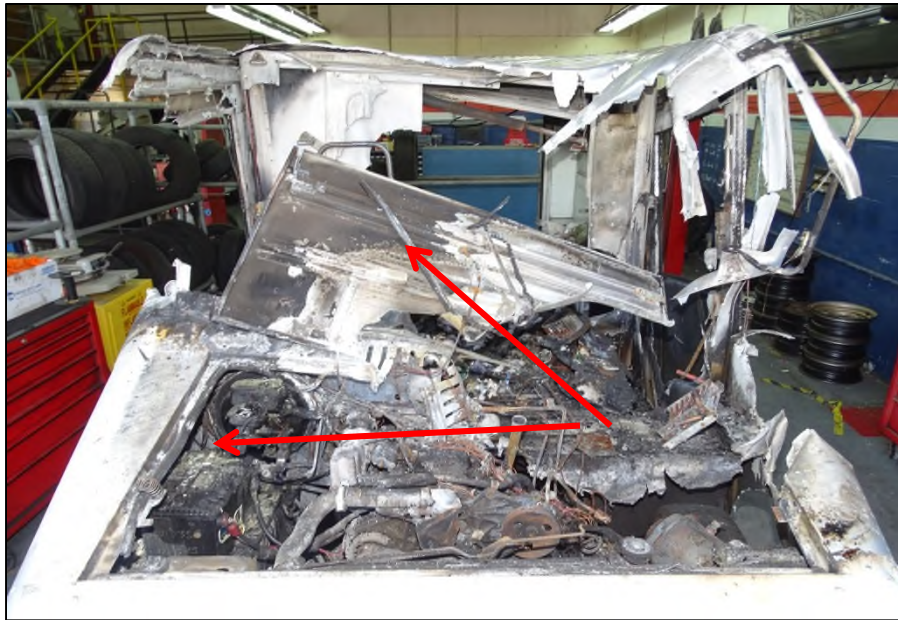
Photograph 9

View of the engine compartment. Note the severe damage on the mail side and the relatively minor damage on the driver's side. Arrows indicated the direction of fire spread.

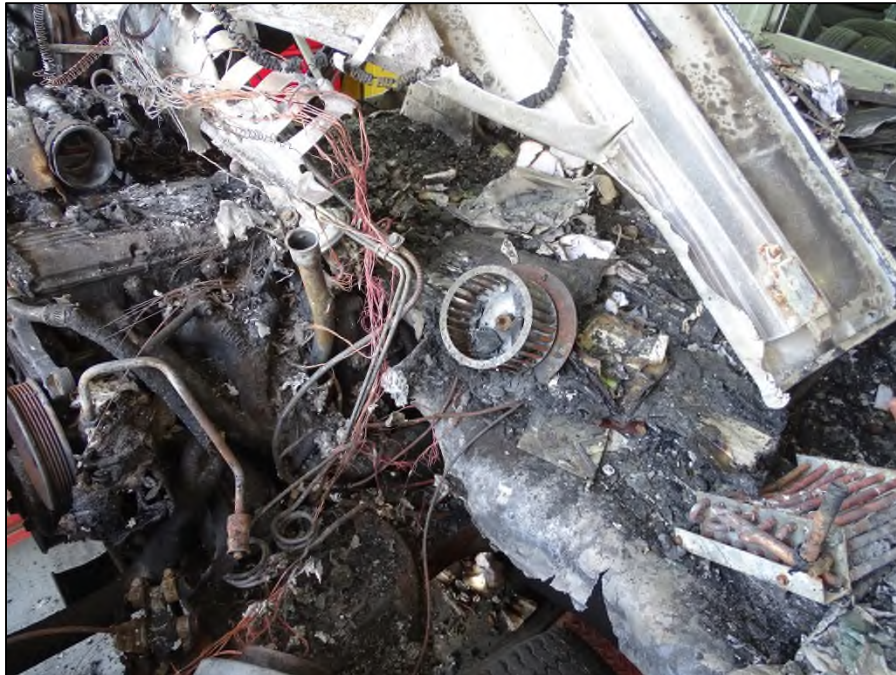
Photograph 13

View of the fire damaged electrical conductors and blower fan housing in the area of origin.

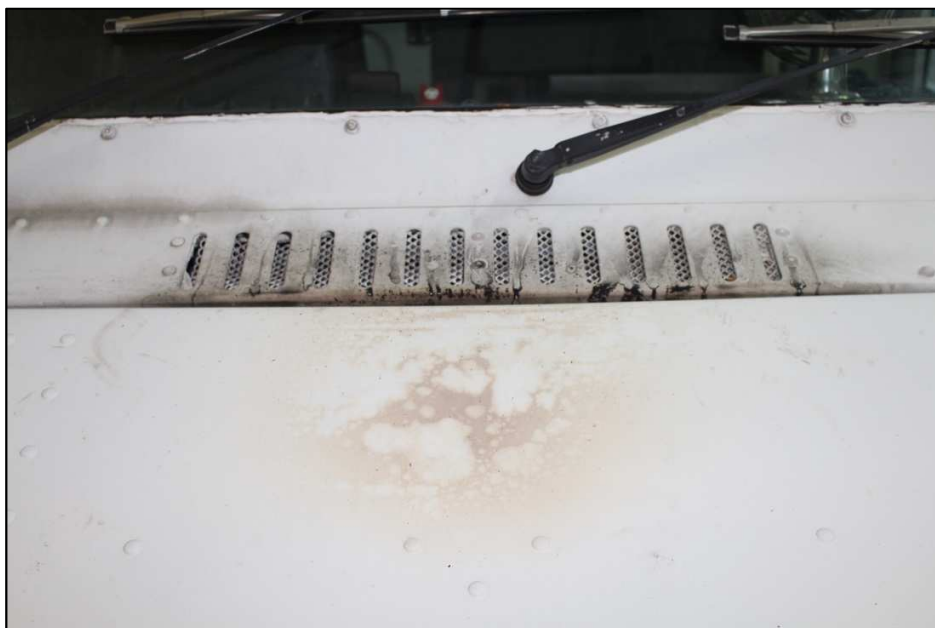
The exterior examination of the vehicle revealed minor fire damage to the front hood of the vehicle, above the engine compartment. Heat damage was observed in the center of the hood towards the windshield.

Photograph 2
Exterior fire damage was observed in the center and towards the windshield of the front hood.

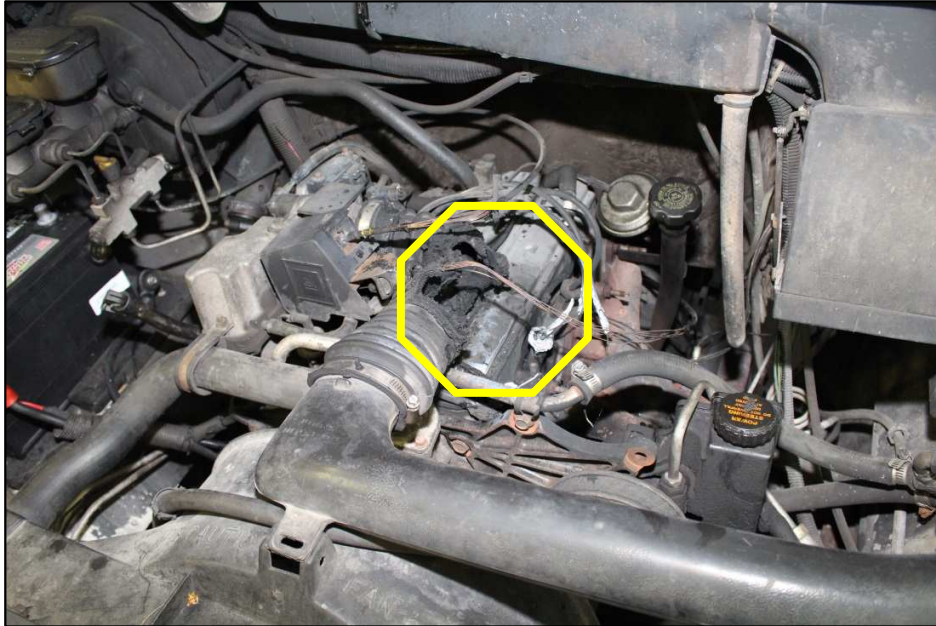
Photograph 3

Burn pattern analysis and an examination of the remaining physical evidence within the engine compartment revealed that the fire originated in the engine compartment. The engine compartment sustained minor damage and the fire appeared to have been extinguished quickly. Fluid levels were observed to be within normal limits. The battery and the main positive and negative conductors were examined and were observed to be free of fire damage or adverse electrical activity. The electrical wiring harness sustained damage where it crossed the front end of the valve cover and near the position of the first spark plug wire. The air intake duct, positioned above the first and second spark plugs, sustained severe damage. The spark plug wire connected to the first spark plug sustained the greatest damage as compared to the remaining spark plug wires. The first spark plug wire was severed and a section of the wire was observed to be missing.

Area of origin within the engine compartment.

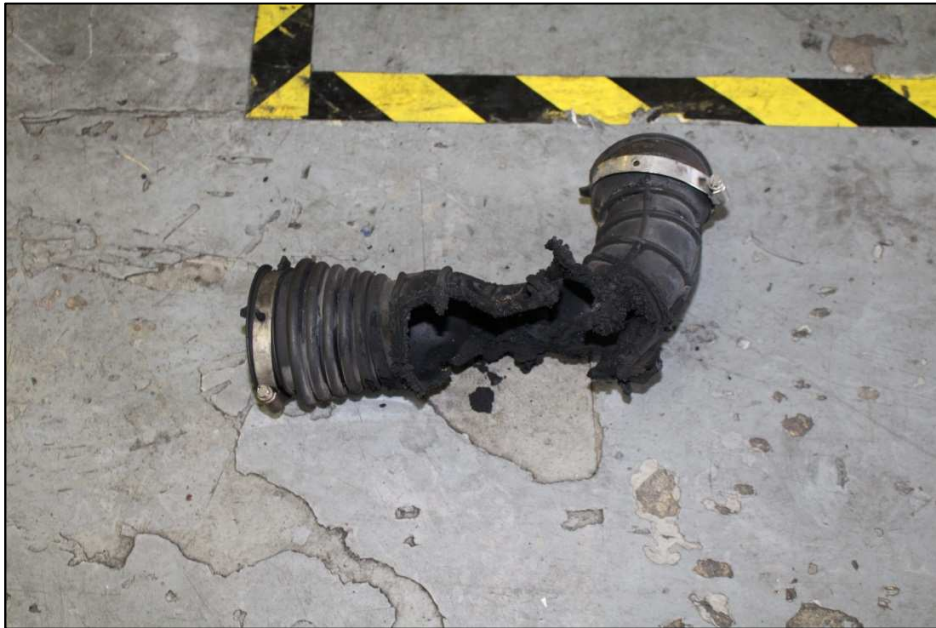
Photograph 5

View of the fire-damaged air intake duct that had been positioned above the first and second spark plug wires.

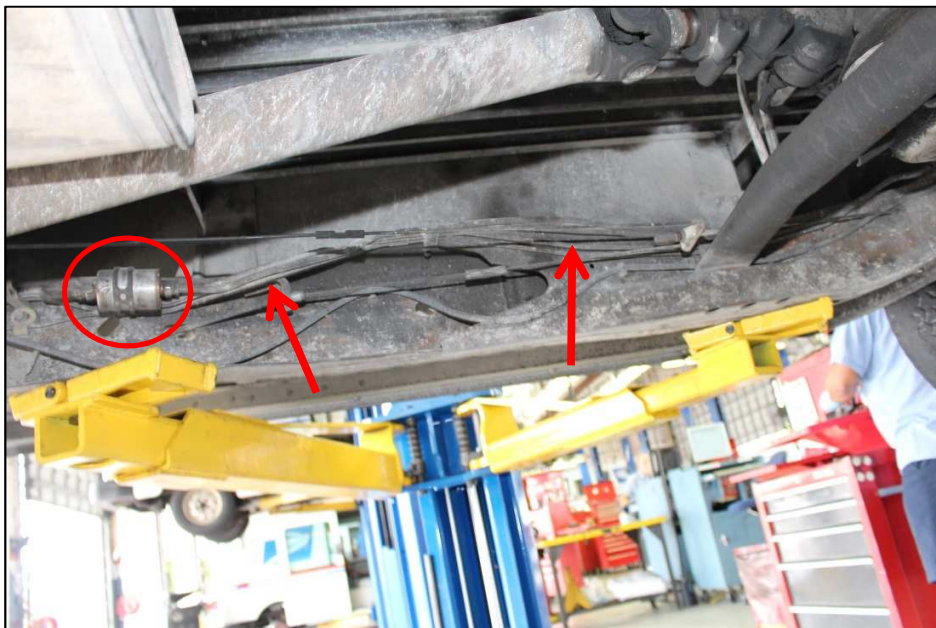
Photograph 8

Examination of the in-line fuel filter and fuel lines revealed no fire damage.

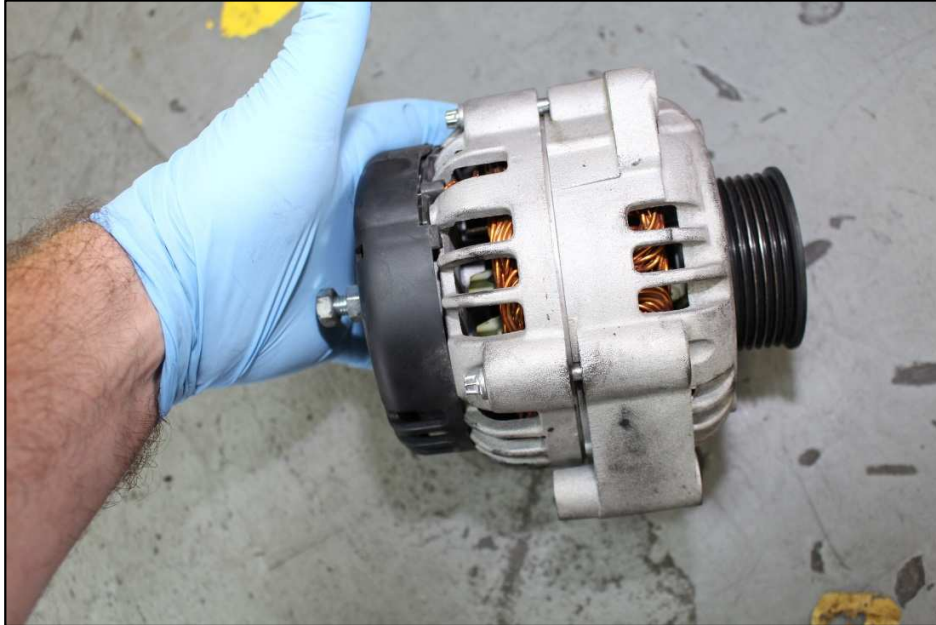
Photograph 9

The alternator appeared to be newer and was free of fire and electrical damage.

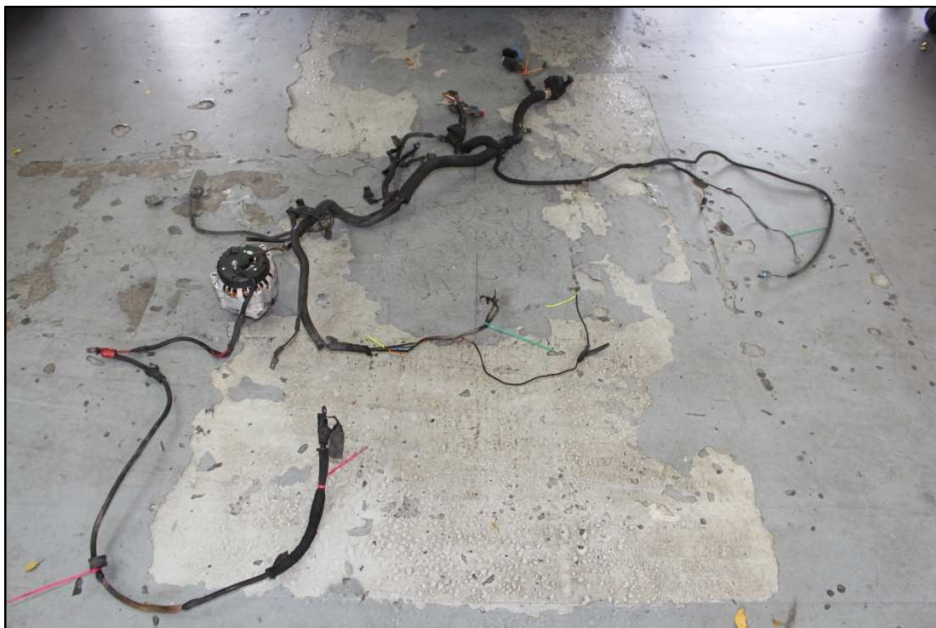
Photograph 10

The wiring harness was removed and collected from the fire-damaged vehicle.

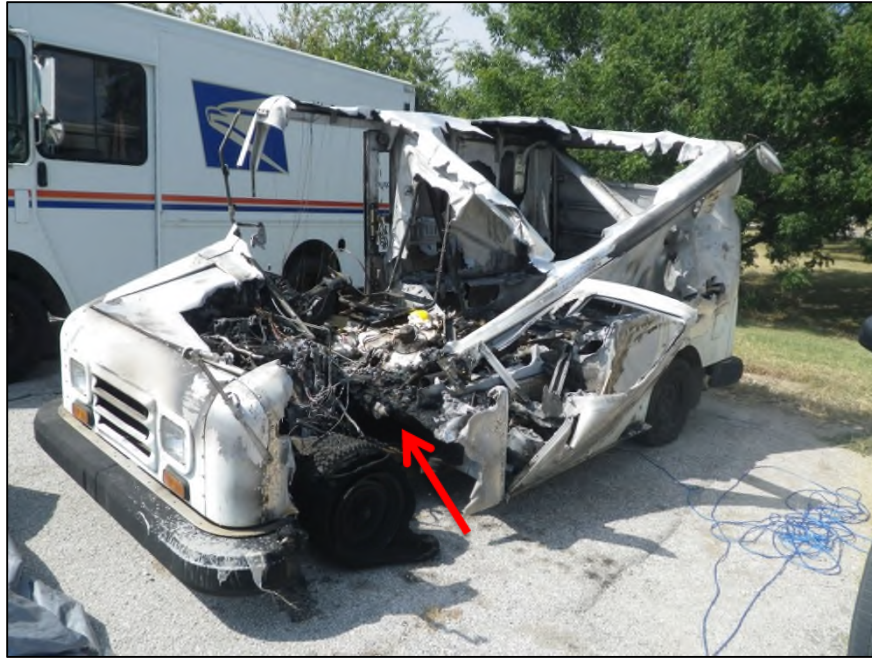
Photograph 1

View of driver's side of vehicle. Area of origin indicated by arrow.

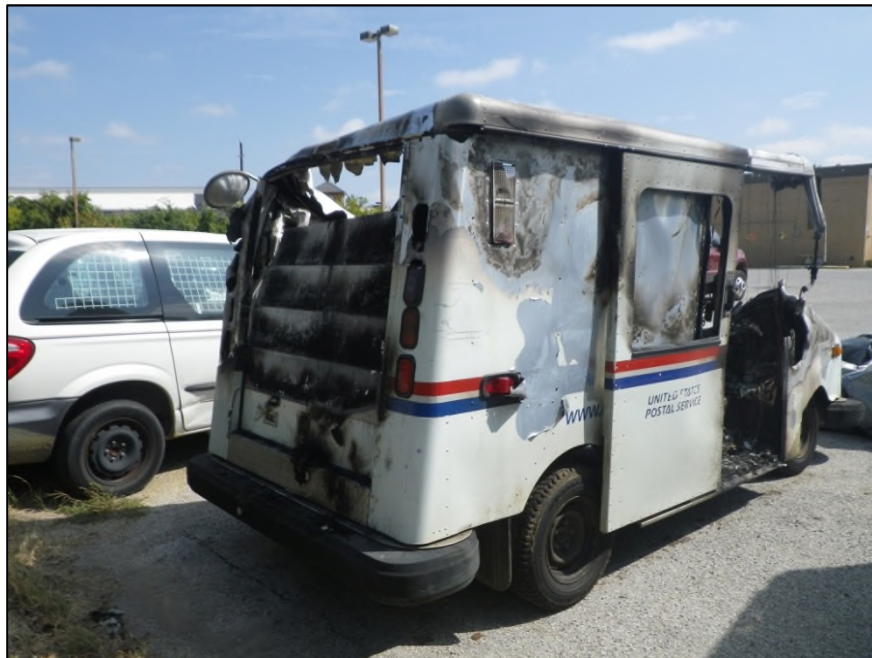
Photograph 2

View of fire damage to mail side and rear of vehicle.

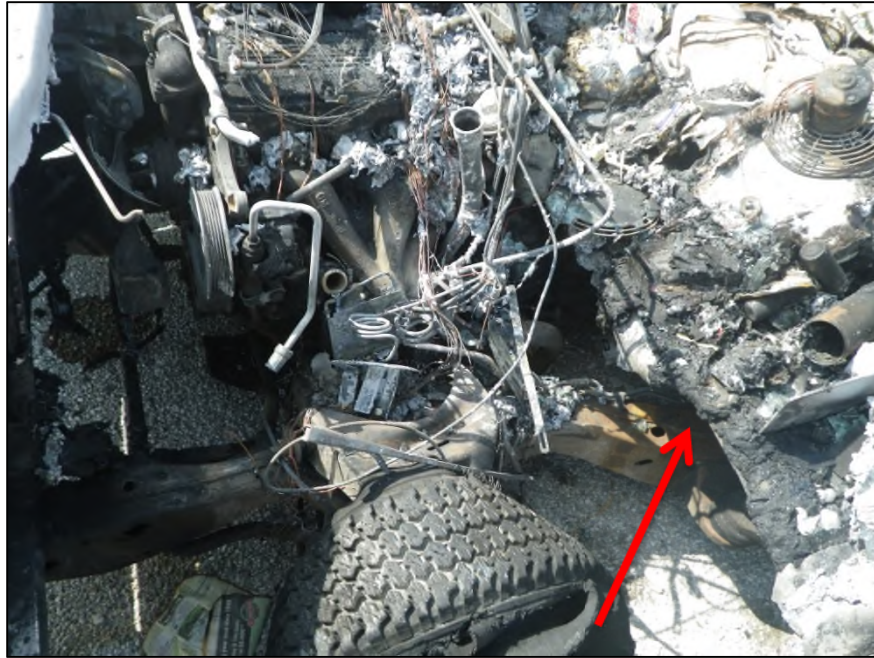
Photograph 3

1. The fire originated on the underside of the engine compartment and involved a failure of a fuel line.
2. Fugitive atomized fuel escaping from the failed line was ignited by the operating components of the exhaust system.

View of fire damage to engine compartment and area of origin.

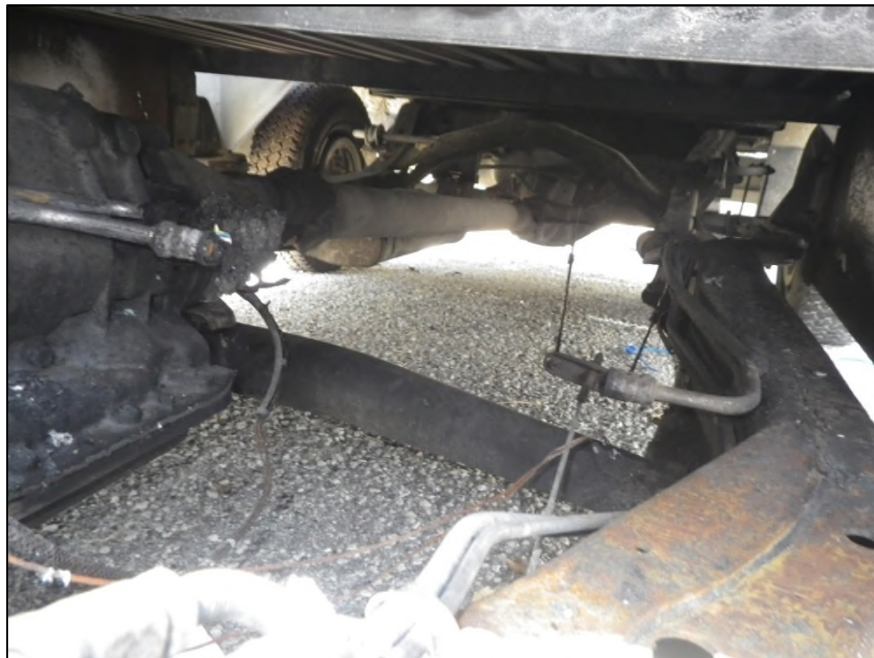
Photograph 4

3. Potential contributing factors for the failure of the line and cause of the fire may have been deterioration to the rubber fuel lines due to aging that resulted in cracks, failures, or possible separation at one of the manufactured connections.

View of two rigid fuel lines, with rubber fuel lines totally consumed.

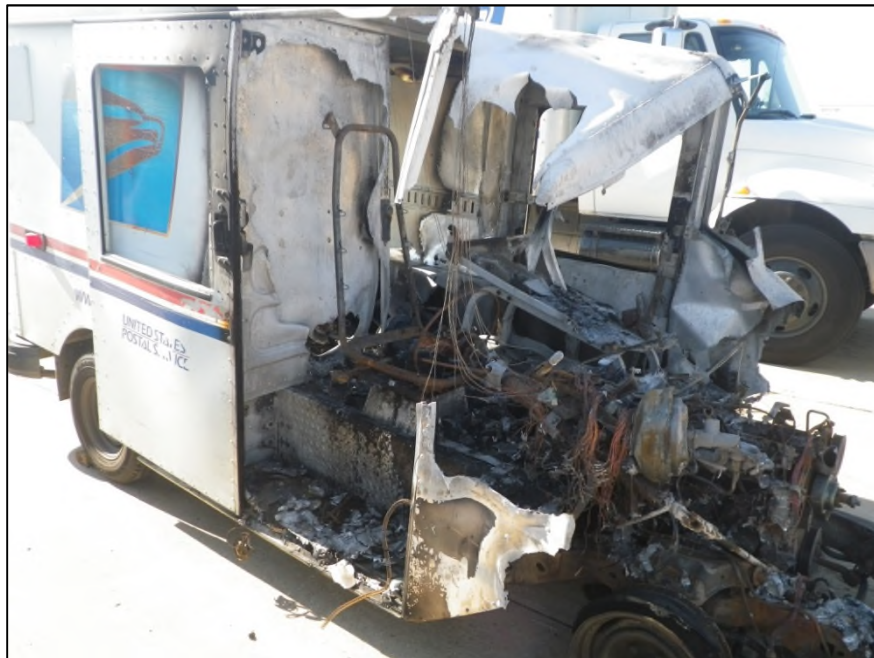
Photograph 2

View of fire-damaged engine compartment and operator compartment.

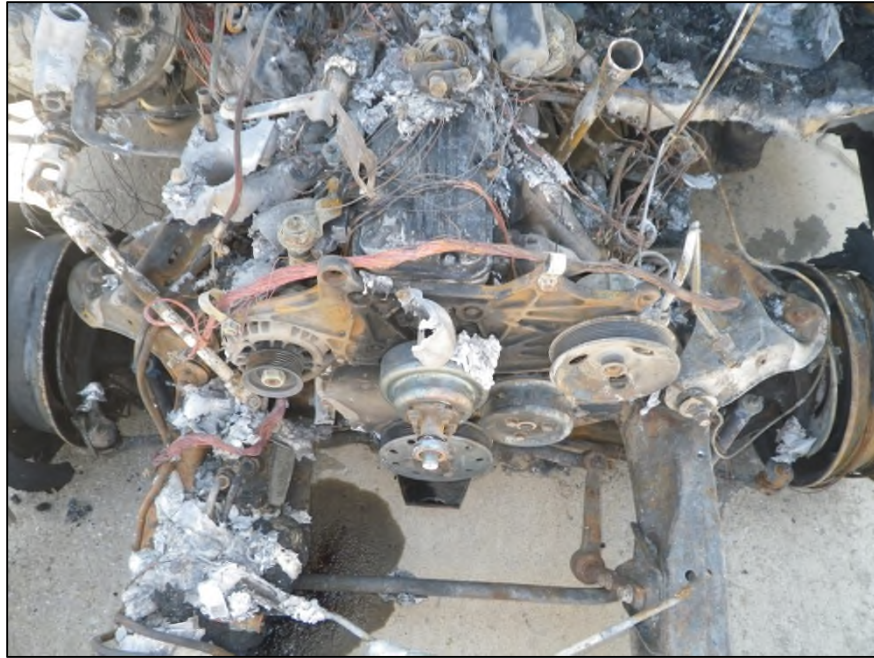
Photograph 3

View of fire-damaged engine.

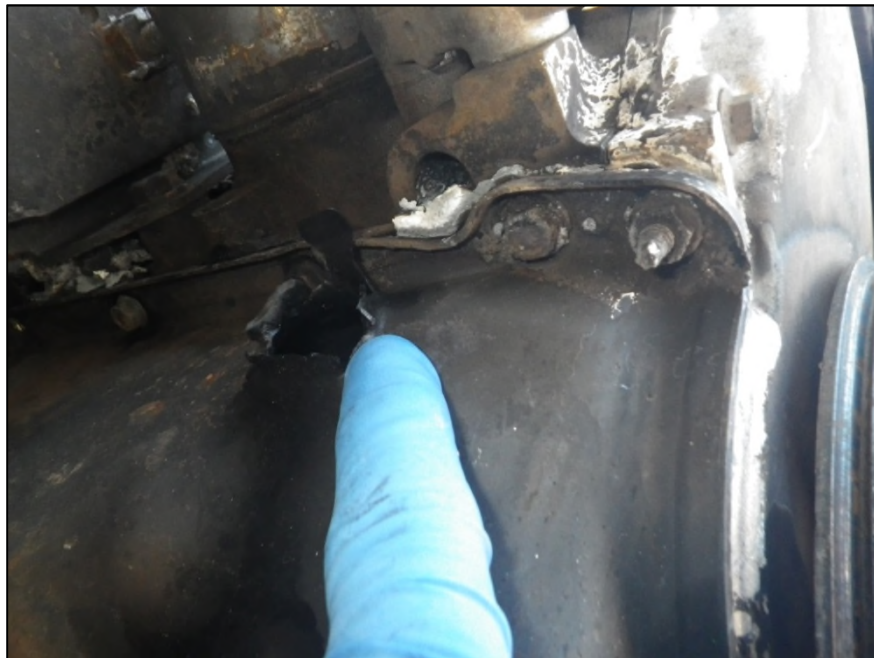
Photograph 4

View of large hole on oil pan on operator side of engine.

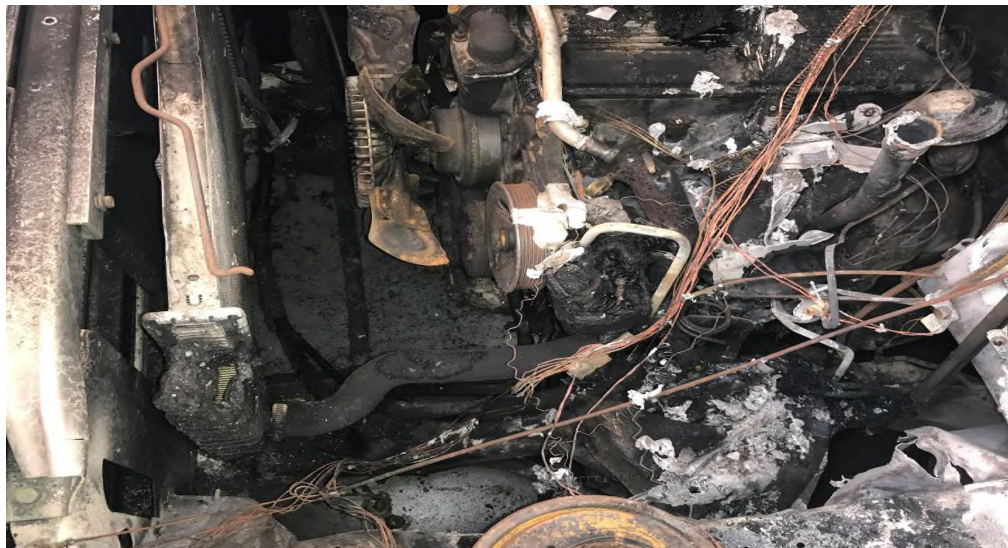
Photograph 2

Heavily fire-damaged area inside engine compartment on left side of engine and area of fire origin.

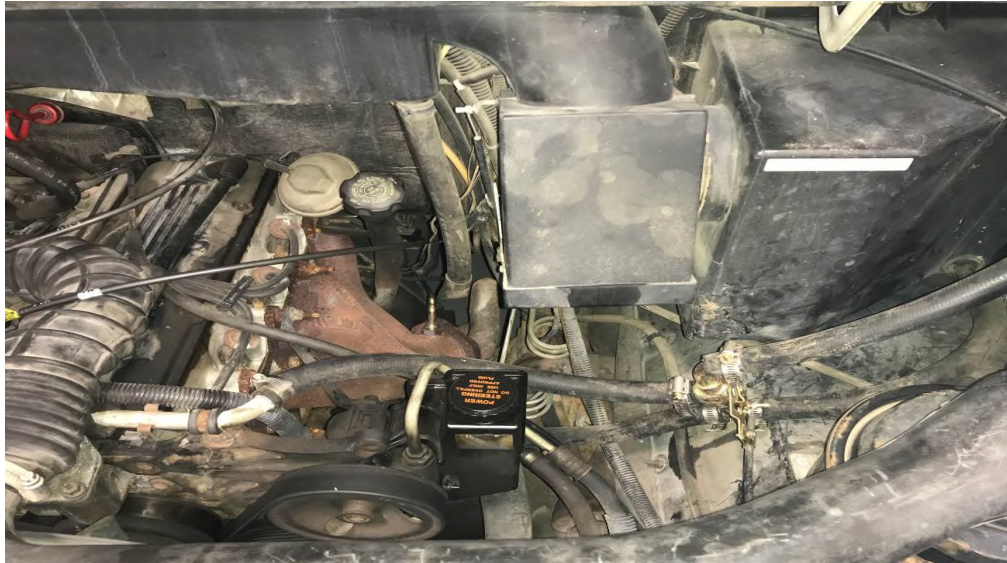
Photograph 3

Comparison of components in same area of fire origin in undamaged exemplar vehicle.

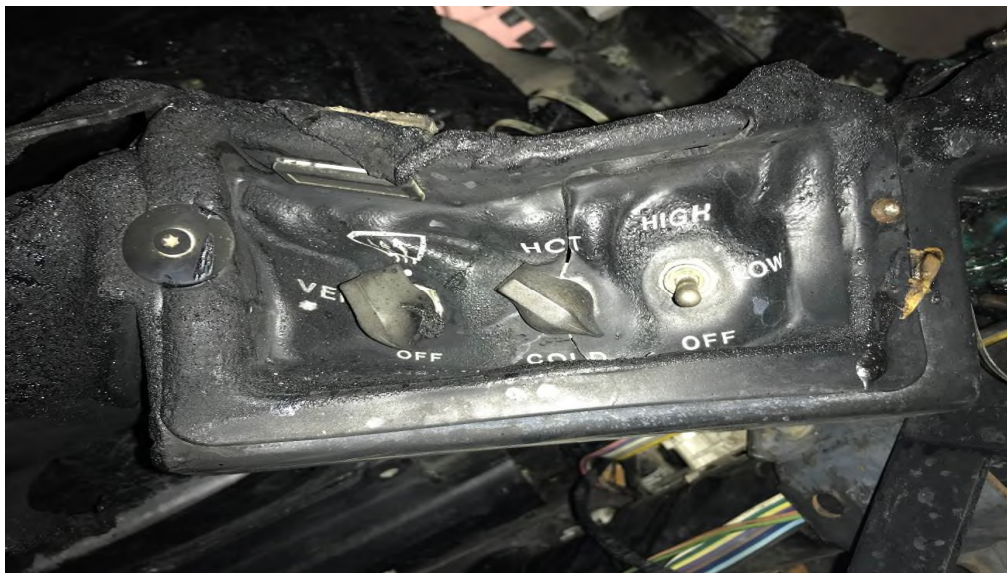
Photograph 4

Controls associated with the climate/blower system were observed in the off position.

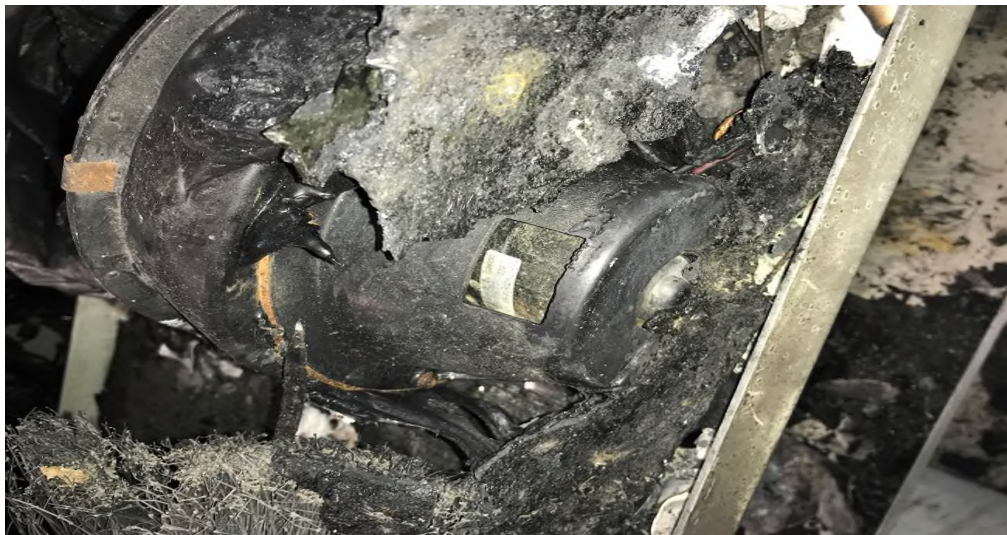
Photograph 6

Examination of the blower motor and associated wiring revealed no evidence of internal failure.

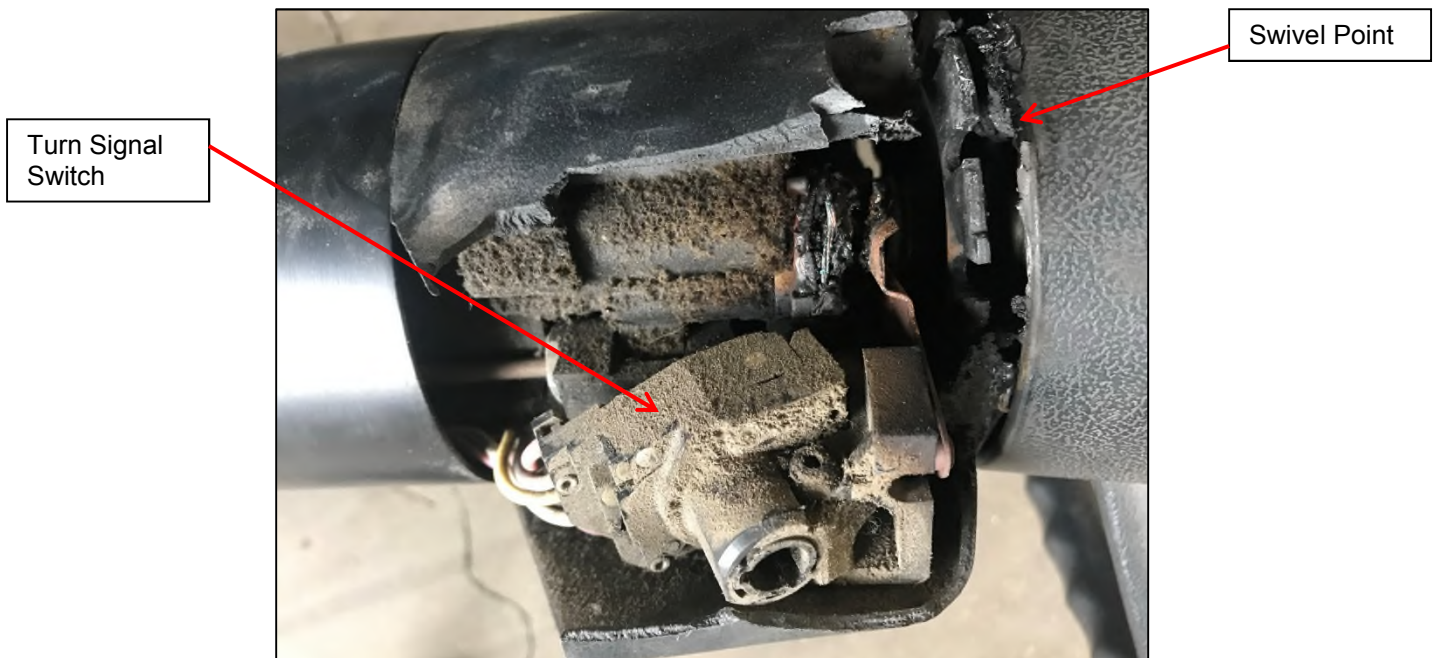
Photograph 2
Steering column at swivel point and turn signal.

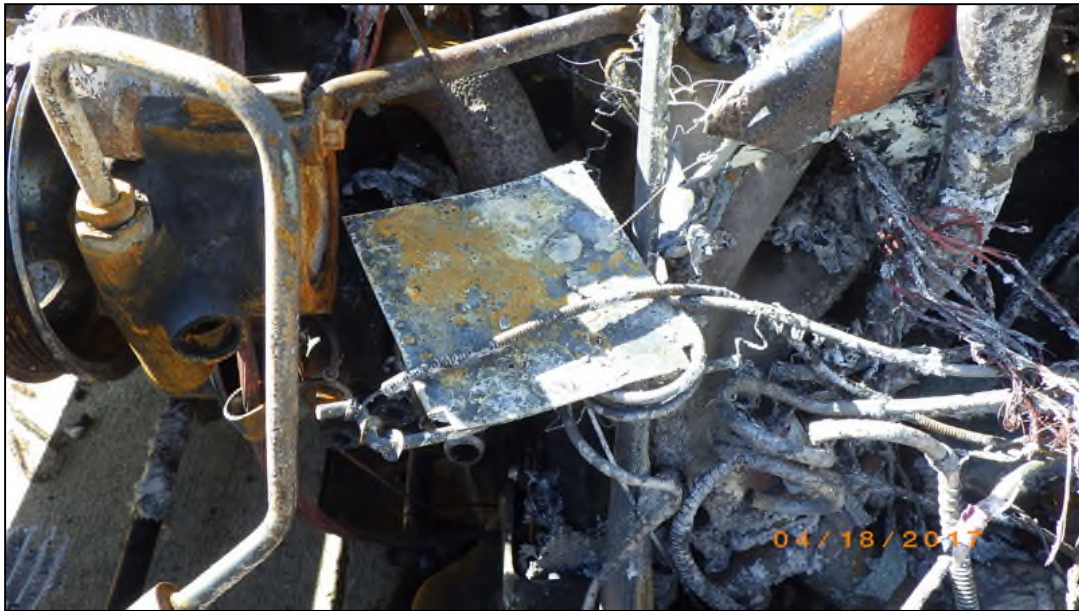
Photograph 11

A view of the area of origin.

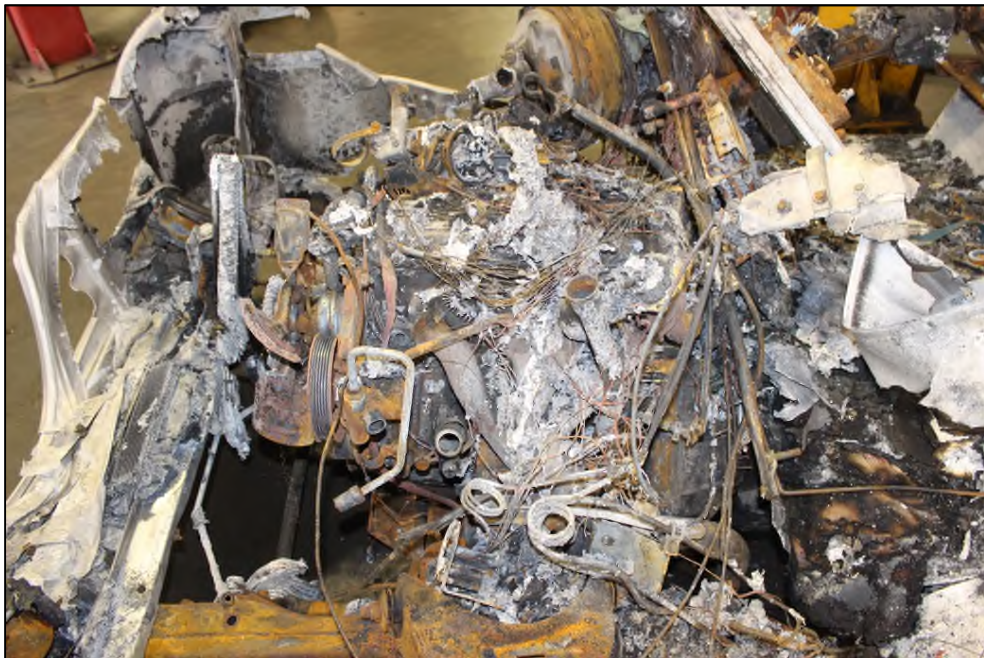
Photograph 10
Top of engine area of fire origin.

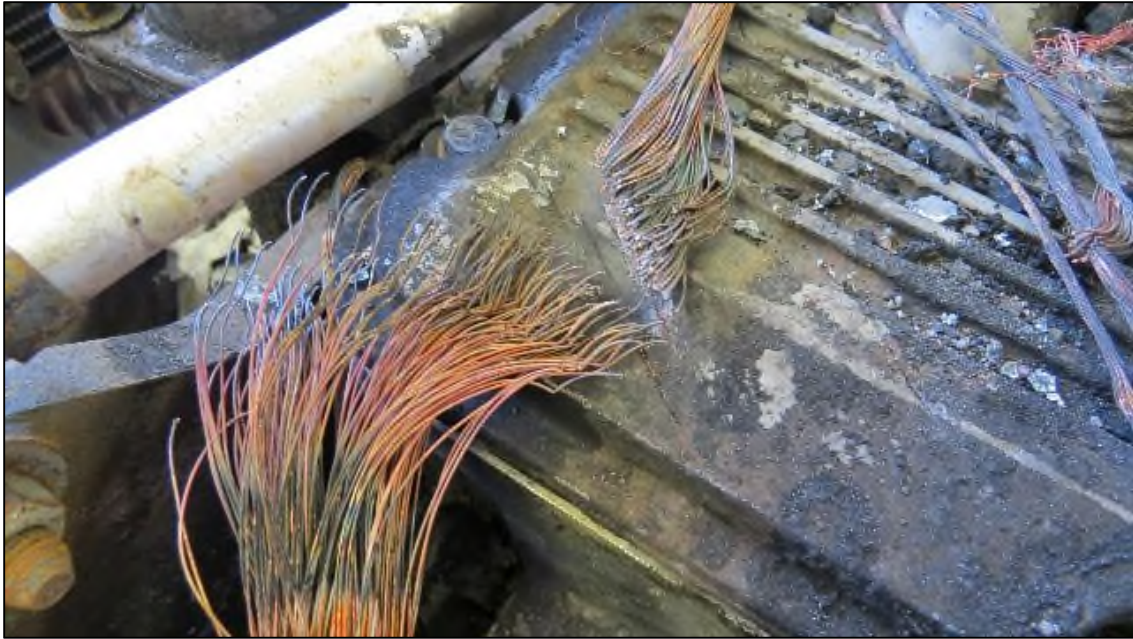
Photograph 3

Severed battery cable and gouges on top of engine valve cover.

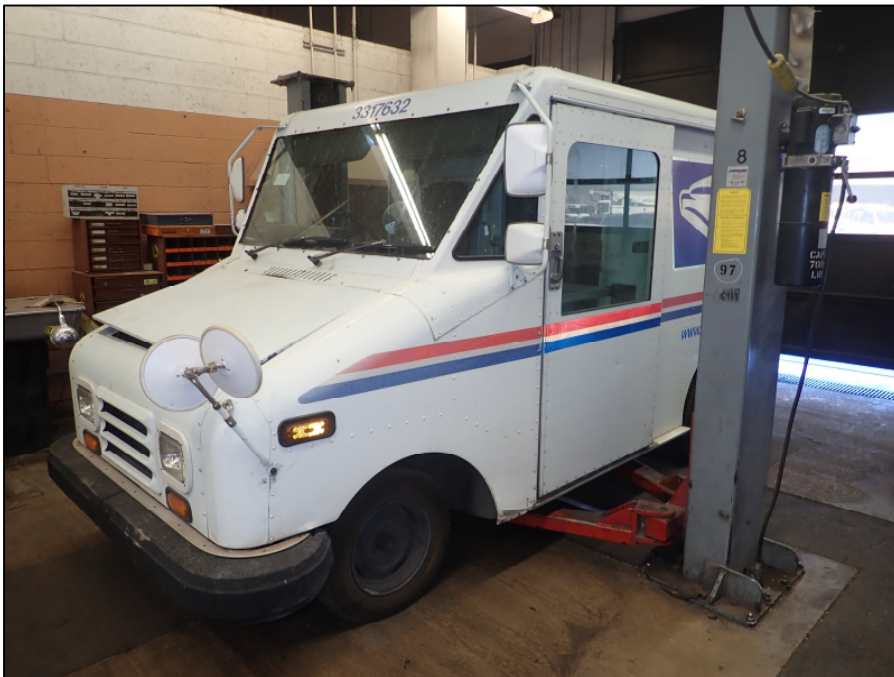
Photograph 2

Front and mail side of LLV 3317632.

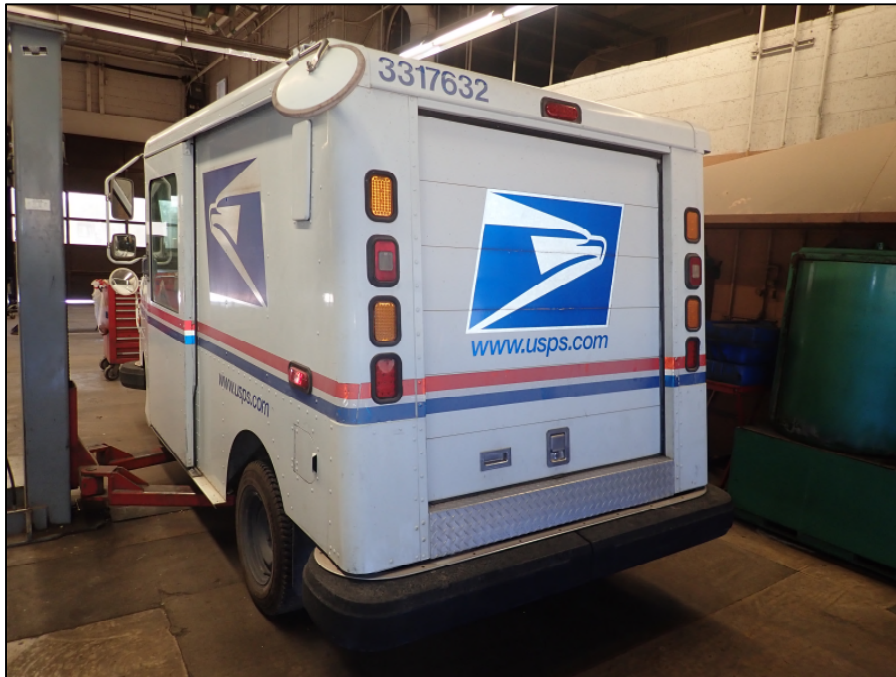
Photograph 3
Rear of LLV 3317632.

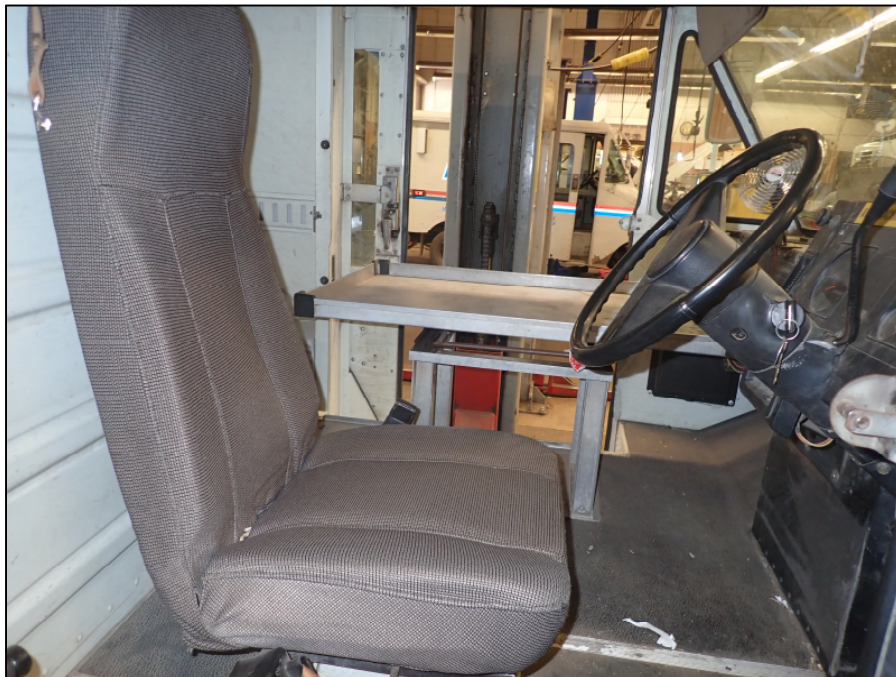
Photograph 4
Driver compartment of LLV 3317632.

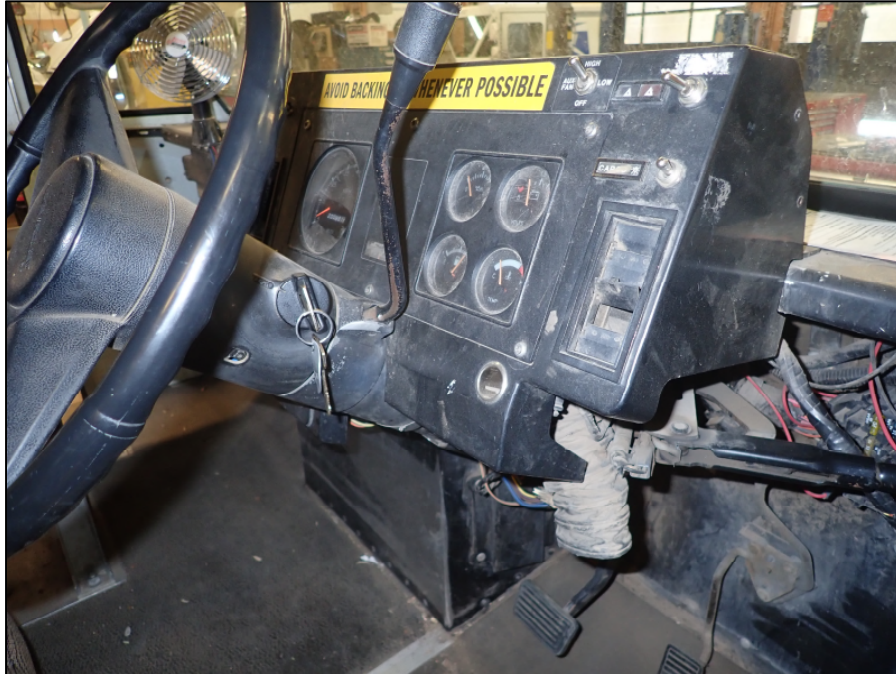
Photograph 5
Dashboard of LLV 3317632.

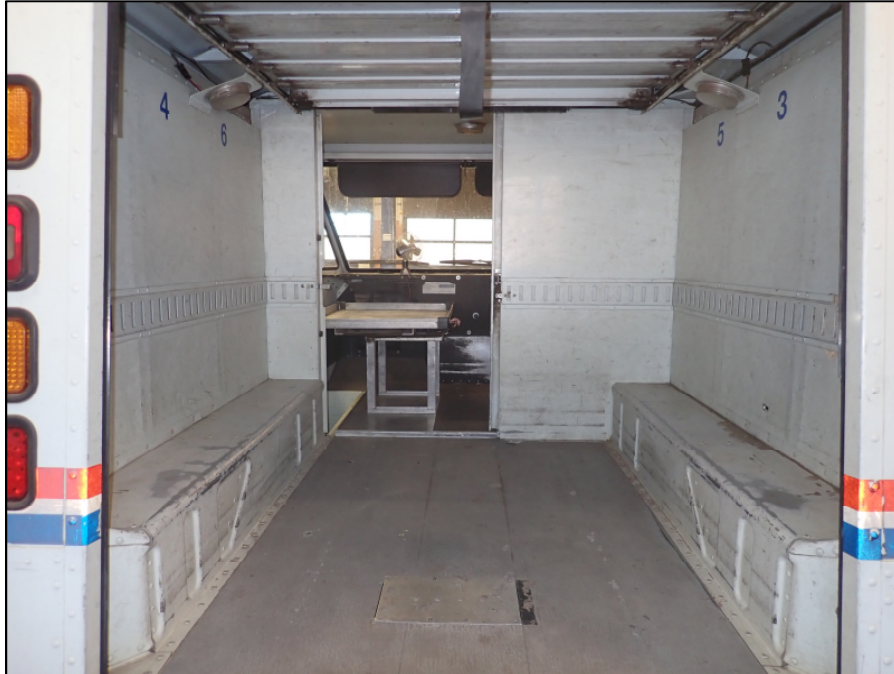
Photograph 7
Cargo area of LLV 3317632.

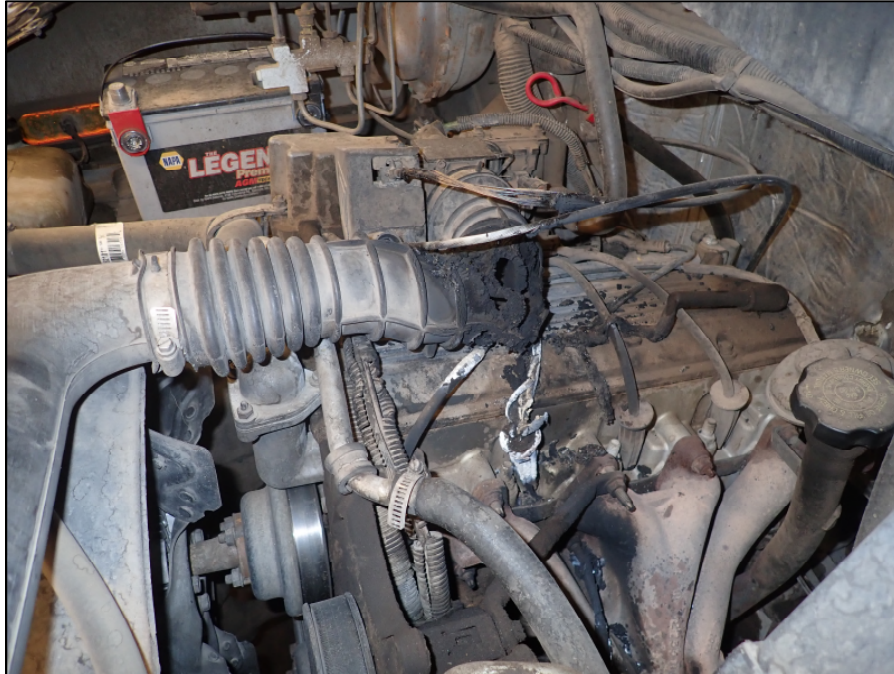
Photograph 9
Area of fire origin.

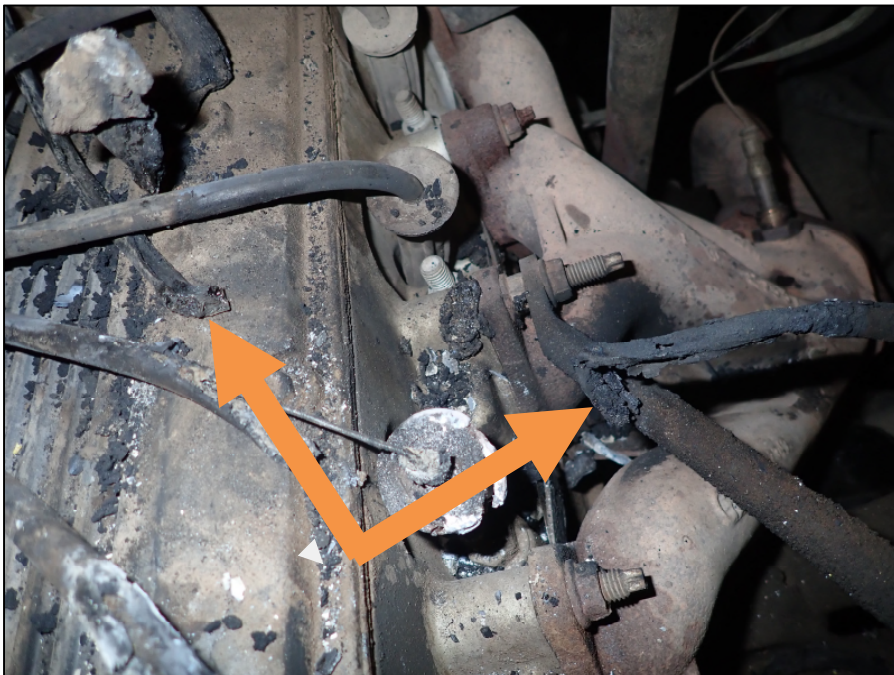
Photograph 10
EVAP canister fuel vapor return line.

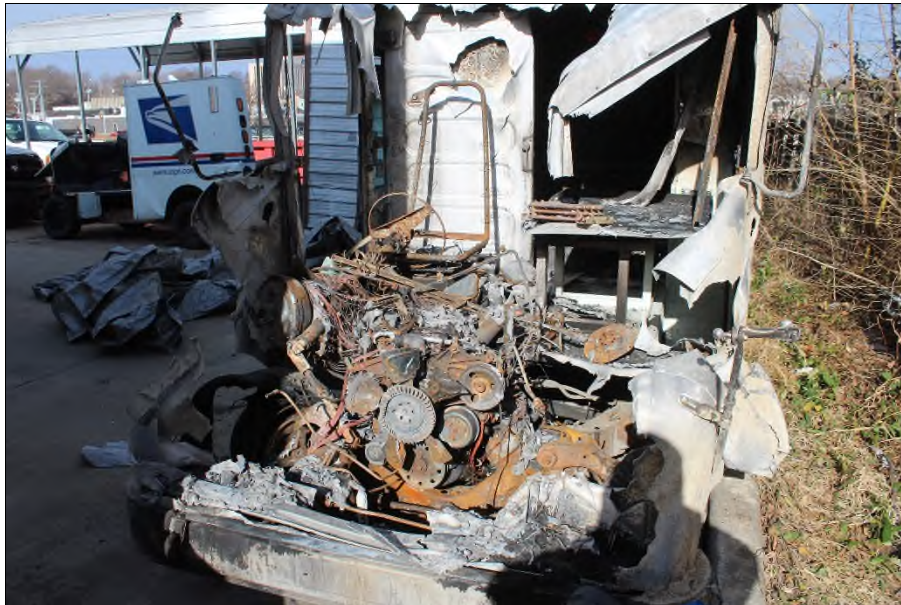
For the purpose of this report, the left side of the vehicle refers to the mail side and the right side refers to the driver's side. We observed heat and direct fire damage with mass loss to the front fender of the driver side and mail side of the LLV. We observed a greater degree of mass loss to the driver side fender. We observed radial patterns on both sides with the convex of the pattern towards the engine compartment. We observed a demarcation line in the damage patterns with the lowest point of the lines towards the engine compartment. All patterns indicated the fire originated in the engine compartment and extended out to the exterior of the vehicle.

Photograph 2
Front of the vehicle with greatest degree of damage to driver side of engine compartment.

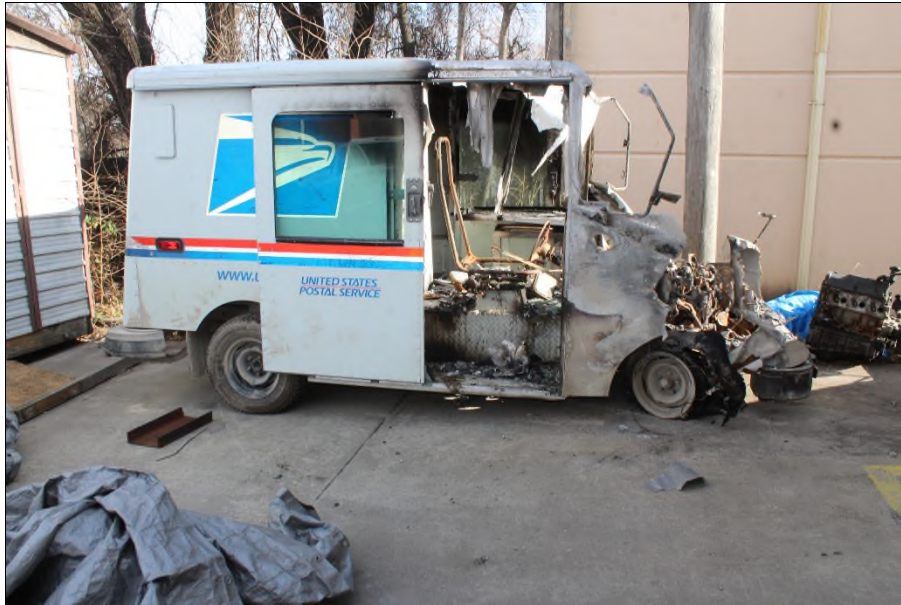
Photograph 3

Driver side exterior showing fire travel originating from the engine compartment.

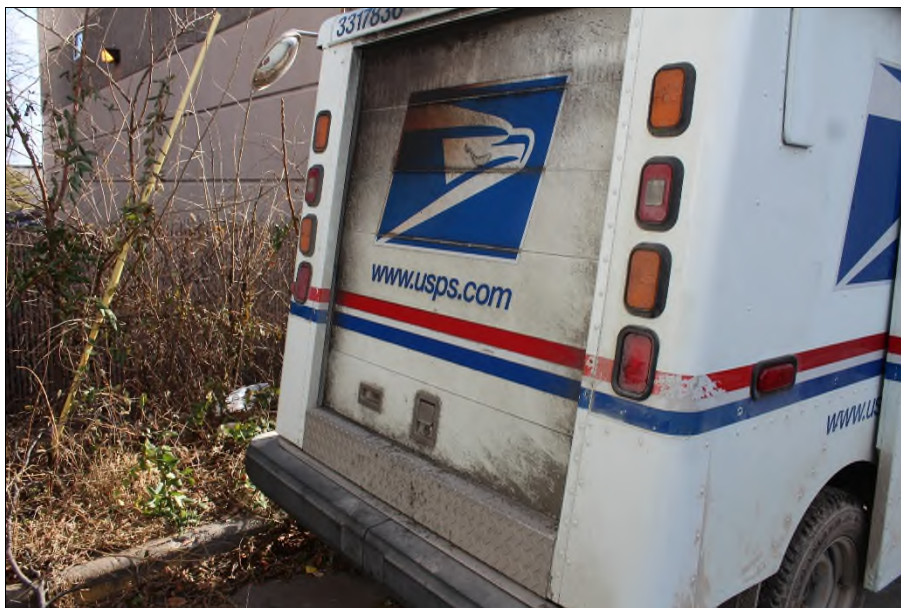
Photograph 4

Rear exterior with smoke damage. Smoke patterns indicated smoke travel was from the cargo compartment.

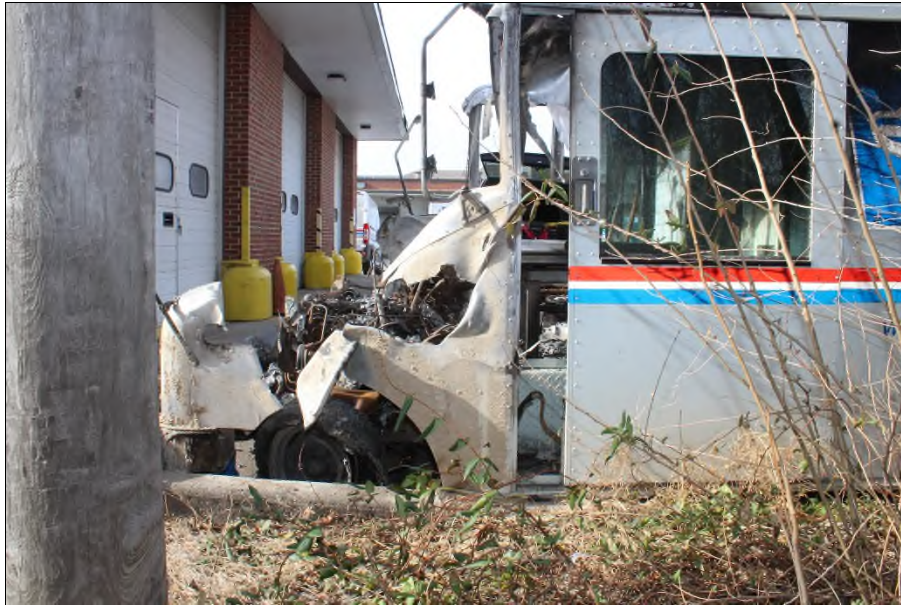
Photograph 5

Mail side exterior showing that the fire originated in the engine compartment.
